Luddenham Advanced Resource Recovery Centre

BIODIVERSITY MANAGEMENT PLAN

Prepared for Coombes Property Group | 11 March 2025

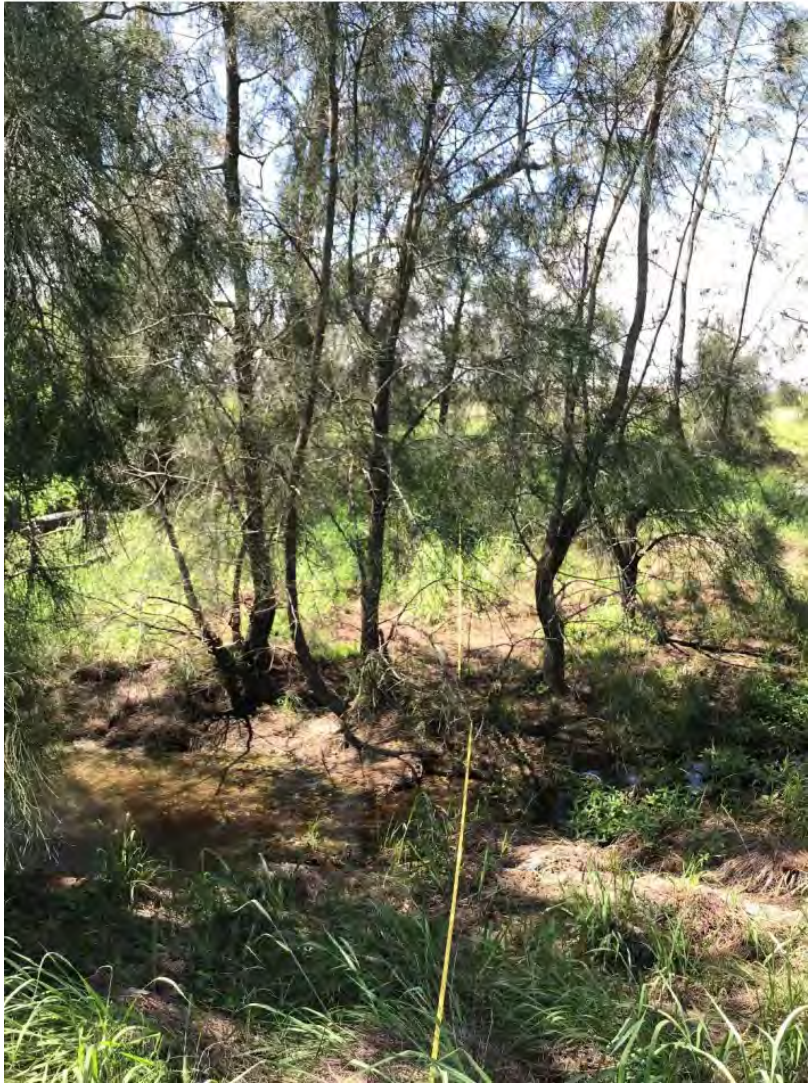
Cumberland Swamp Oak riparian forest within the ARRC site (Medium condition - plot ID P03).

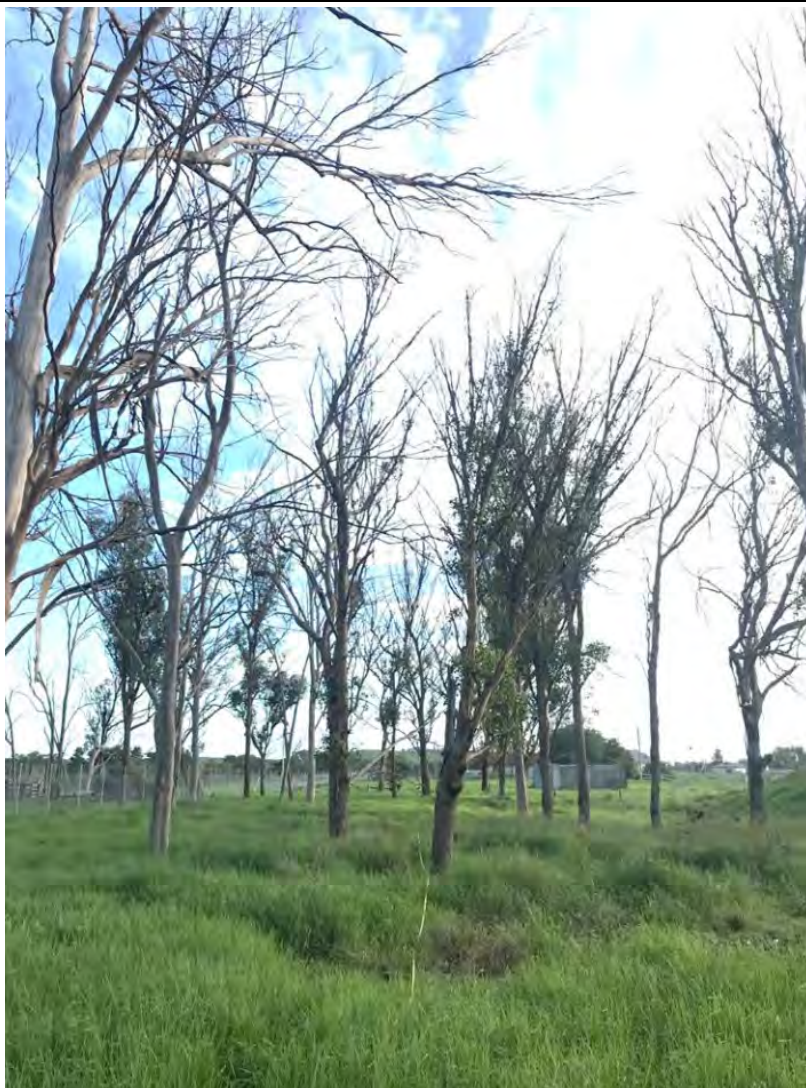
Estimate of percent cleared value of PCT within NSW	93%
Grey Box – Forest Red Gum grassy woodland on flats of the Cumberland Plain, Sydney Basin Bioregion within the subject property (Poor condition – plot ID P01).
